**EXPERIMENTAL EVALUATION OF THE RESIDUAL CONCRETE-  
REINFORCEMENT BOND AFTER EXPOSURE TO ELEVATED TEMPERATURES**

Dissertation submitted to the Civil Engineering  
Graduate Program of the Universidade Federal de  
Viçosa in partial fulfillment of the requirements for  
the degree of *Magister Scientiae*.

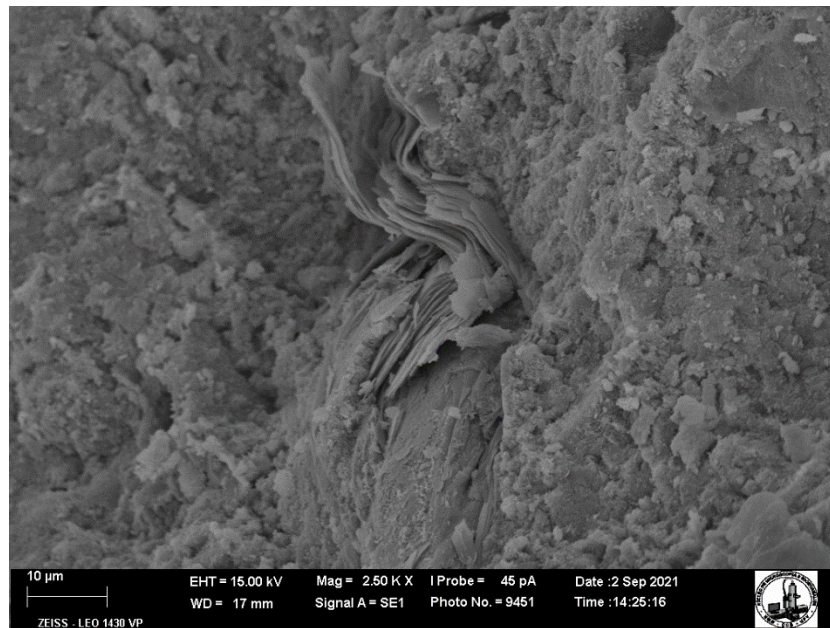
**Fig. 19.** Portlandite decomposition in C50 after exposure to 600 °C.
